Division 5 Asbestos Hazardous Building
Materials Assessment
Maribyrnong River Children's Centre -
Shed (Bldg No. 242.1)
6 Wests Road,
Maribyrnong 3032

Maribyrnong City Council

June 2014

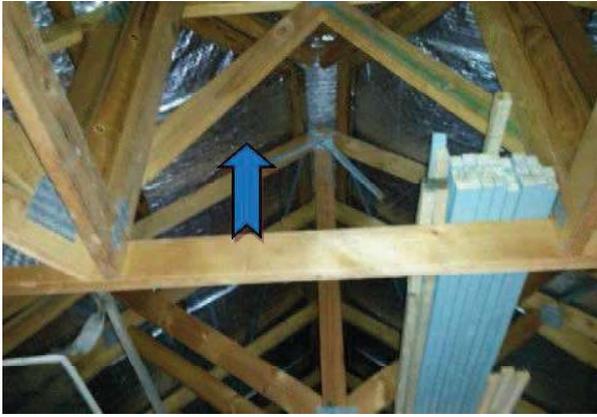
Sarking insulation material in the roof lining was suspected to contain SMF.

| Area / Level | Room & Location | Feature | Item Description | Hazard Type | Sample No. | Sample Status | Friability | Disturb. Potential | Condition | Risk Status | Quantity | Recommendations & Comments | Control Priority | Reinspect date | Photo No. |
|---|---|---|---|---|---|---|---|---|---|---|---|---|---|---|---|
| Ground Floor | Roof lining | Insulation | Sarking insulation | SMF | - | Suspected Positive | Bonded | Low | Good | Low | 20 m ² | Maintain in current condition if to remain in-situ. Remove under controlled SMF conditions as per Code of Practice for the Safe Use of Synthetic Mineral Fibres (NOHSC: 2006 [1390]). | - | - | 1 |

Photo 3. Bldg 242.1, roof lining, sarking insulation suspected to contain SMF.

SMF materials that are likely to be disturbed during any proposed demolition/refurbishment works should be handled in accordance with the National *Code of Practice for the Safe Use of Synthetic Mineral Fibres* [NOHSC:2006(1990)].
