Division 5 Asbestos Hazardous Building
Materials Assessment
Maribyrnong River Children's Centre -
Shed (Bldg No. 242.1)
6 Wests Road,
Maribyrnong 3032

Maribyrnong City Council

June 2014

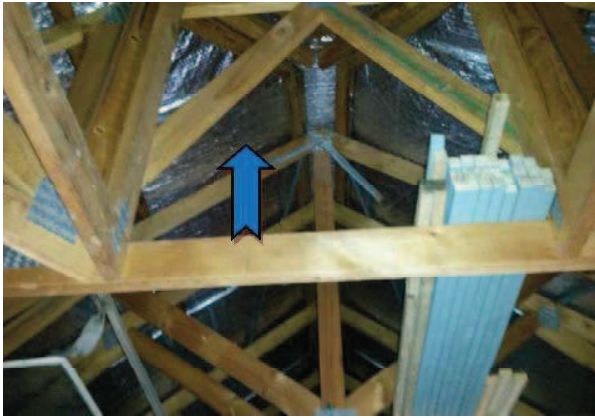
Sarking insulation material in the roof lining was suspected to contain SMF.

Photo 3. Bldg 242.1, roof lining, sarking insulation suspected to contain SMF.

SMF materials that are likely to be disturbed during any proposed demolition/refurbishment works should be handled in accordance with the National *Code of Practice for the Safe Use of Synthetic Mineral Fibres* [NOHSC:2006(1990)].
